# Permeable paving – what's the concrete evidence?

Date: 6 June 2018  
Presenter: Candace Jordan and Dale Browne

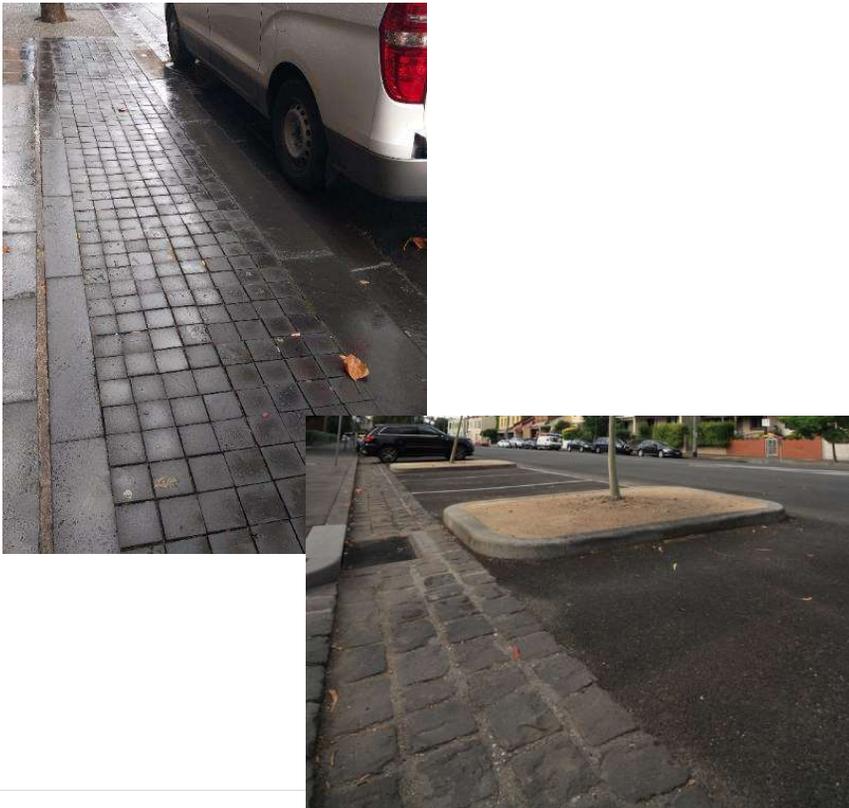
Modular paving - Collins St, Melbourne

Site	Pre-clean Infiltration rate (mm/hr)
Collins St	525
Eades Place	200
Harris St	0.01
Abbotsford St	0.01

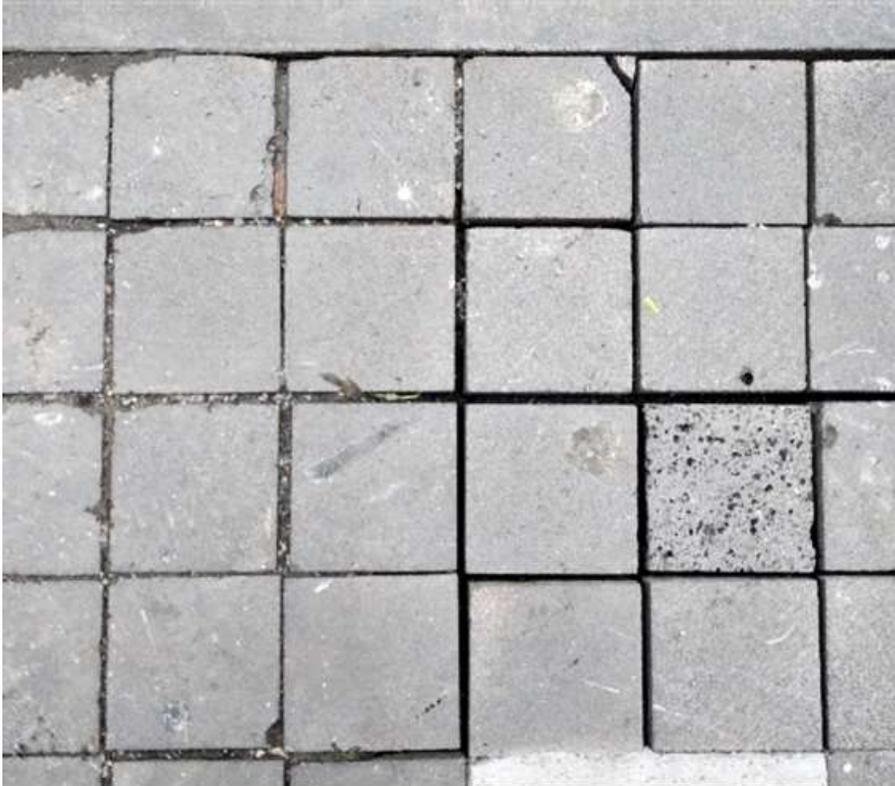
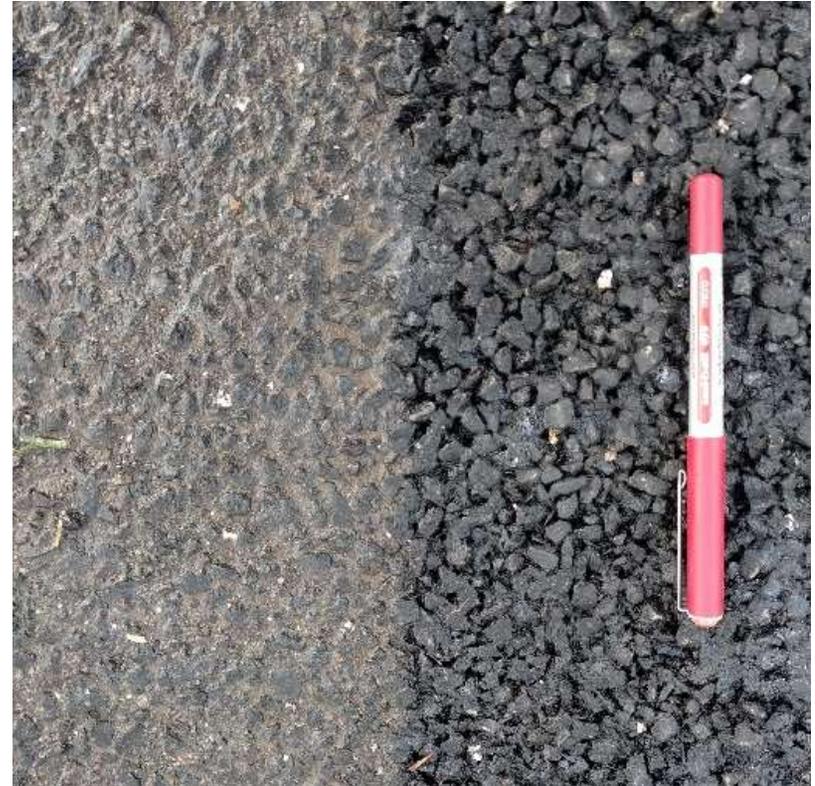
**Visually effective, but does it improve infiltration?**

Permeable Pavement System	Pre-clean Infiltration rate (mm/hr)	Post-clean Infiltration rate (mm/hr)
Collins St	525	16,200
Eades Place	200	5,700
Harris St	0.01	5,600
Abbotsford St	0.01	2,500

**Yes! A clear benefit of cleaning was demonstrated**
