# Permeable paving – what's the concrete evidence?

Date: 6 June 2018  
Presenter: Candace Jordan and Dale Browne

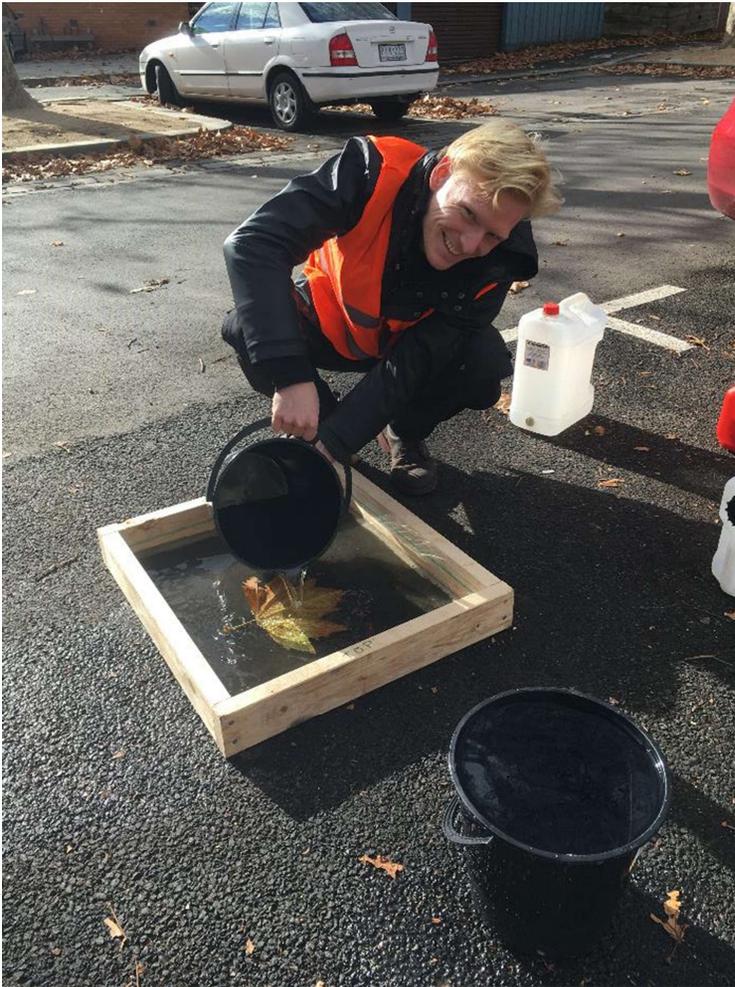
Site	Pre-clean Infiltration rate (mm/hr)
Collins St	525
Eades Place	200
Harris St	0.01
Abbotsford St	0.01

**200-500 is ok, still infiltrates most storms**  
**0.01 is no good**

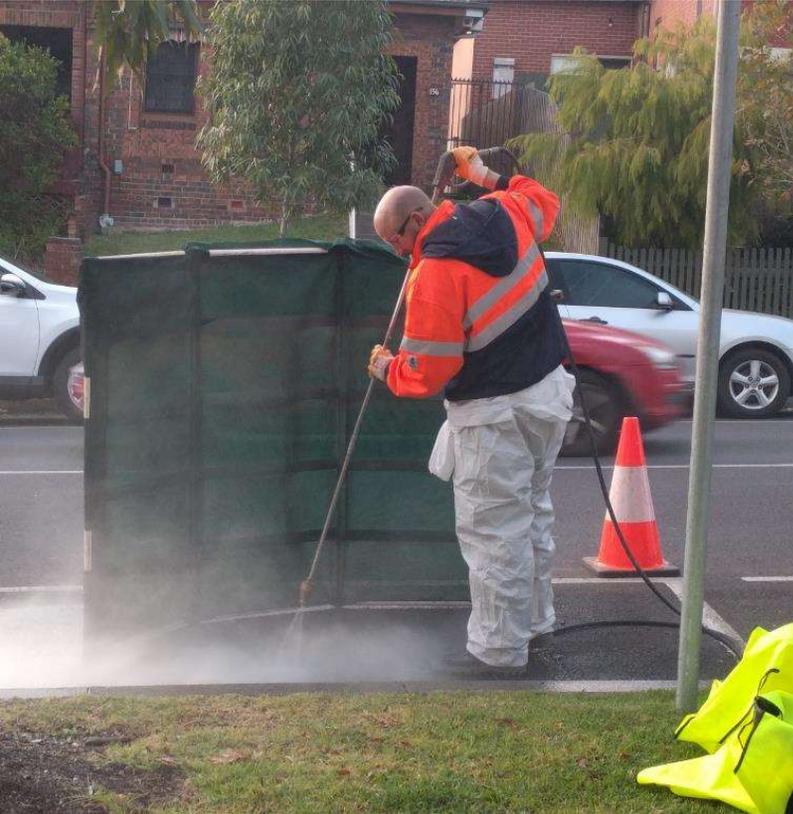
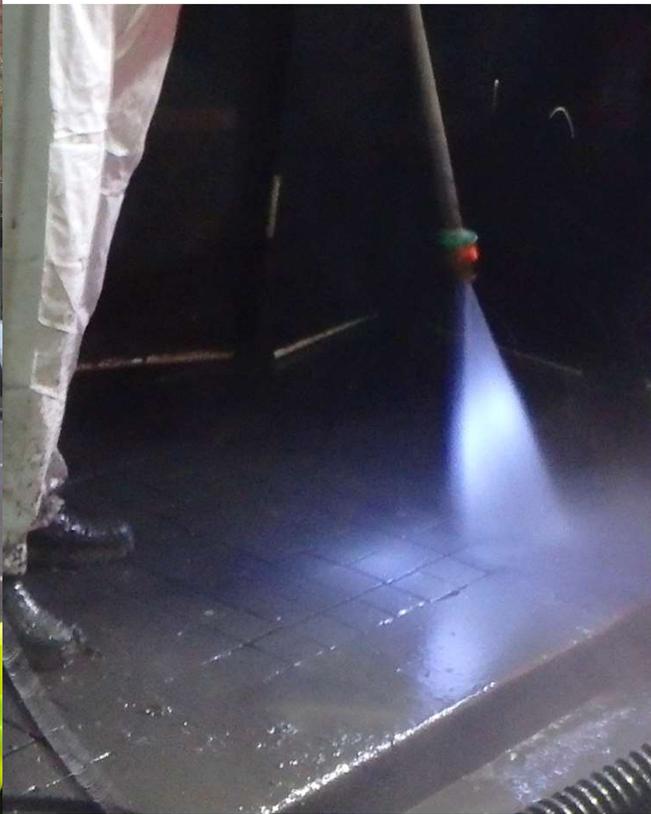
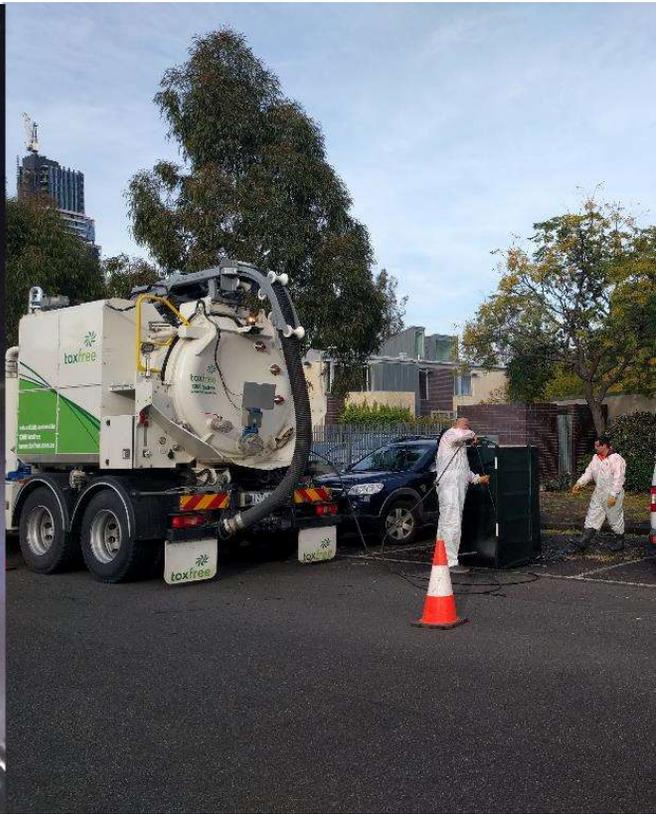
**Visually effective, but does it improve infiltration?**

Permeable Pavement System	Pre-clean Infiltration rate (mm/hr)	Post-clean Infiltration rate (mm/hr)
Collins St	525	16,200
Eades Place	200	5,700
Harris St	0.01	5,600
Abbotsford St	0.01	2,500

**Yes! A clear benefit of cleaning was demonstrated**
