Innovative Passive Irrigation Soak Wells in Moonee Valley

5 June 2019

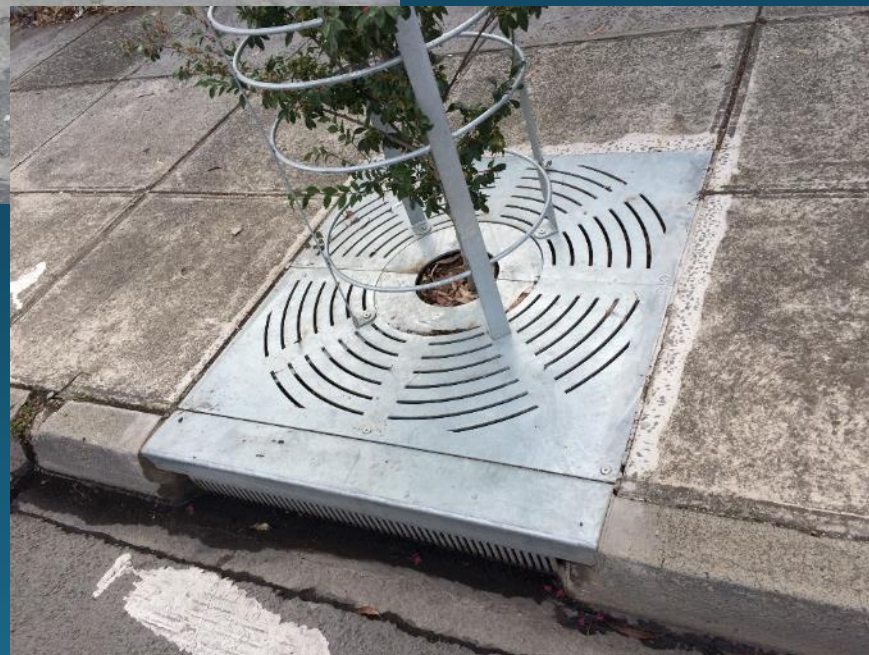
Sediment build-up
blocking water inflow

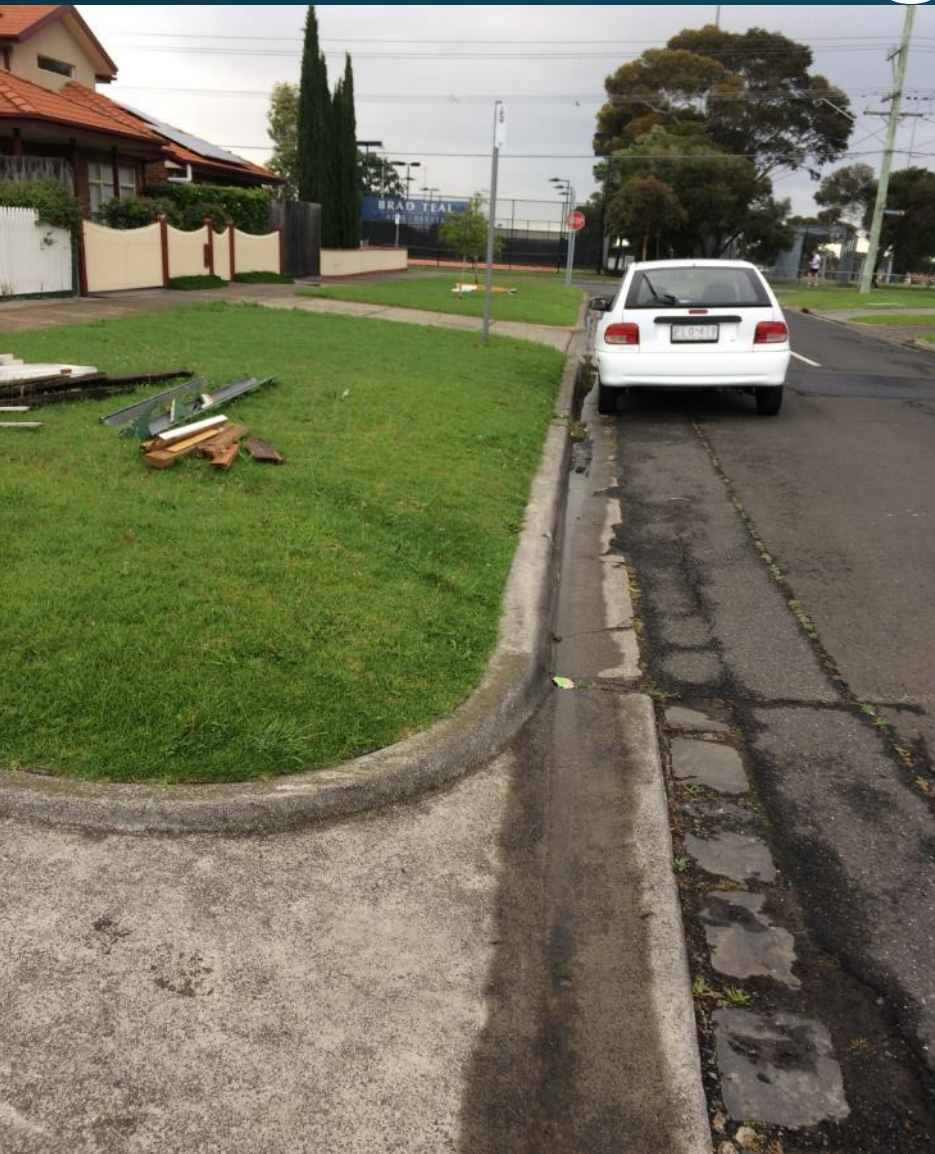
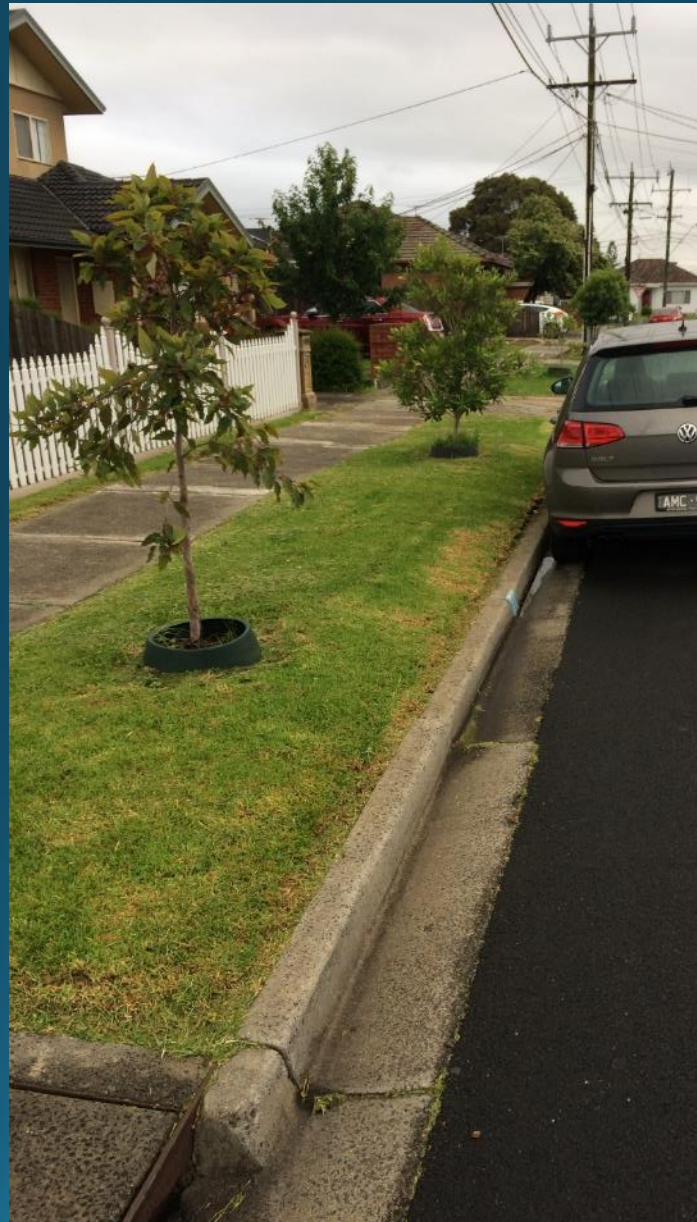
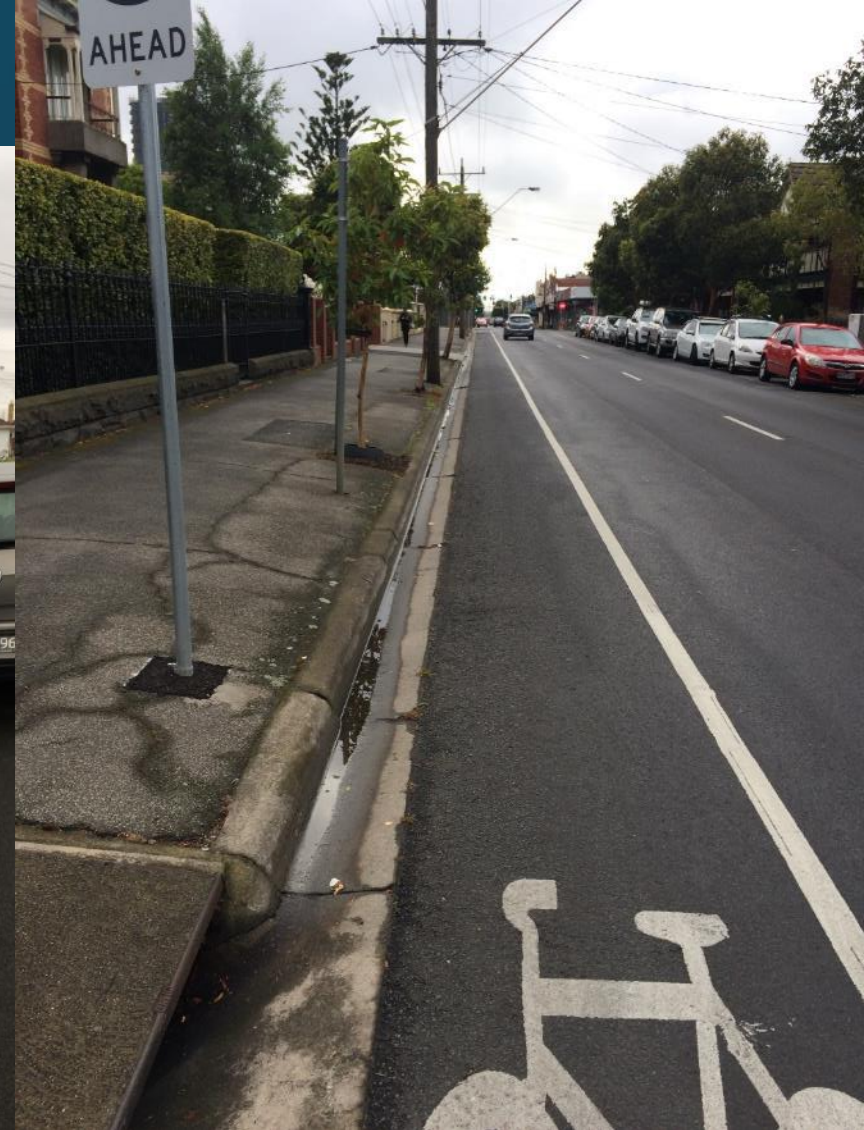
Site meeting

- Mounded nature strips makes a cut-out back of kerb difficult with level changes, size and mowing maintenance for residents
- Large width with trees in centre – significant size of cut-out
- Resident or council to maintain?
- Passive irrigation or raingarden?
- Idea is not to change looks of street significantly
- Avoid negative aesthetics of trapping litter at surface level
